# SPCPlus 主介面

## 常用工具注釋

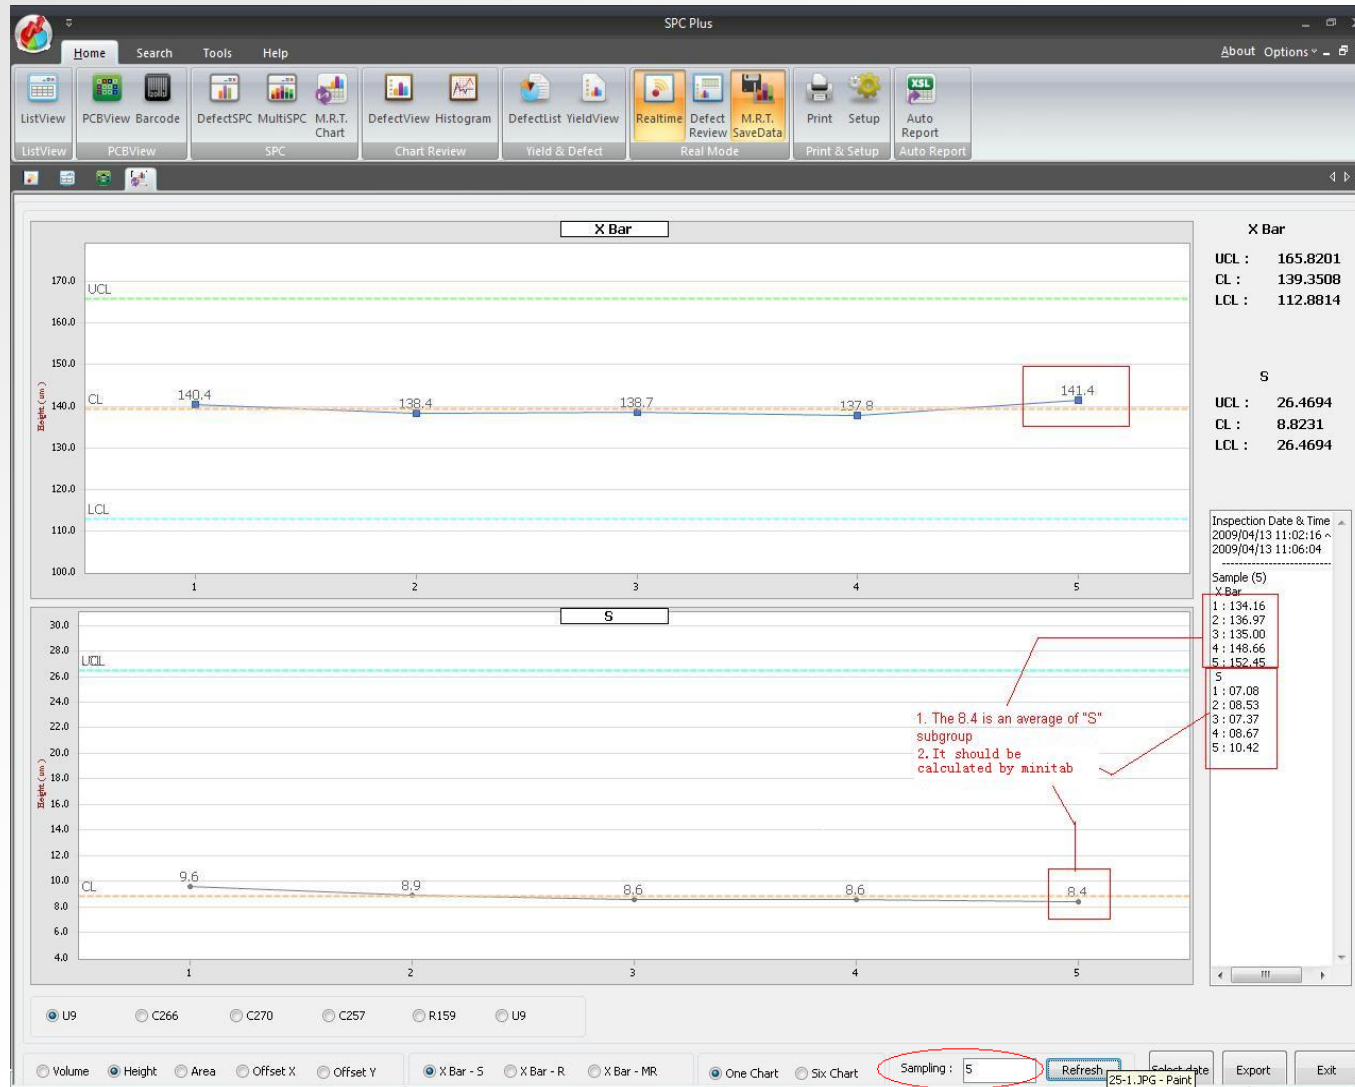
# MRT Chart

Sampling: pcb 數量
